## Installation Instructions for Cessna 210 without Air Conditioning KIT RCS-300-3 (R1180003)

Doc: 9051-0118-017

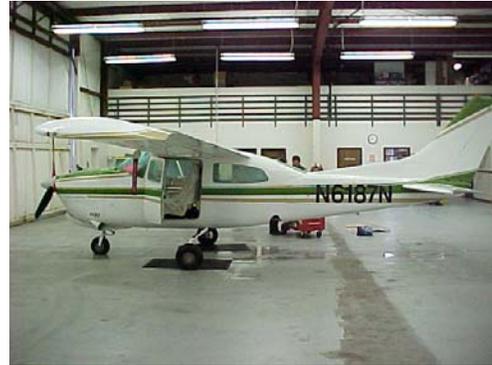
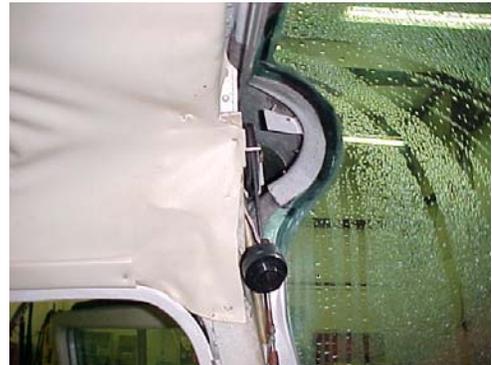
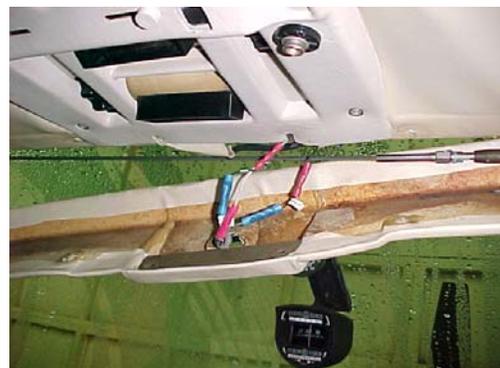
- Remove old visors mounted to overhead console.
- Remove pilot side plastic trim piece covering vertical post. Remove stall warning horn from trim piece by unscrewing cover cap and sliding warning horn out.
- Remove horizontal center trim piece running from pilot side post to co-pilot side post.
- Expose spar near corner posts by gently pulling headliner material up off of fabric hooks riveted to forward section of spar.
- While sitting in pilot seat and looking up at spar, locate gusset (or angle piece) running from top of post to spar.

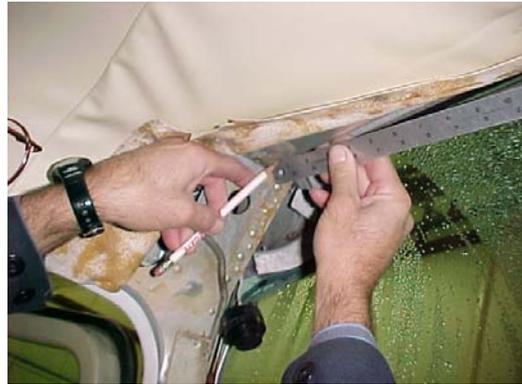
Pencil mark bottom of spar  $\frac{3}{4}$ " inboard of gusset.

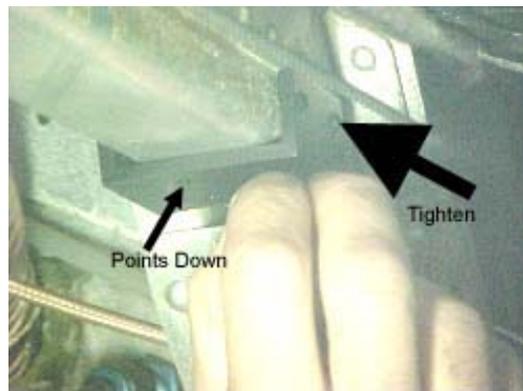
- Slip channel clamp (1180104) over spar, with left edge of clamp in alignment with pencil mark, and short flange facing forward.
- Uniformly tighten front and rear cone screws with  $\frac{1}{8}$ " Allen wrench provided. (Ensure that channel clamp is pushed up as close to spar as possible.)
- Install three #8 set screws with sharp point down (these screws are used to mark horizontal trim piece in order that holes can be drilled in proper locations). Screws should be installed 'finger tight' only (see figure at right), as they will be removed and re-used when installing co-pilot side visor.

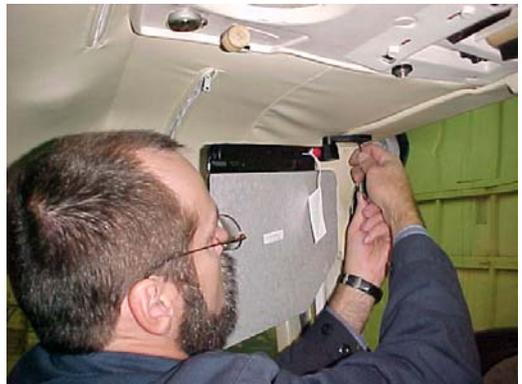
- Carefully realign horizontal trim piece running across spar. When in *original* position, push firmly up against #8 pointed screws protruding from channel clamp. These marks can now be punched or drilled with  $\frac{3}{8}$ " bit. Drill *through plastic trim only*, as drilling through fabric headliner will stretch or tear material.
- Remove #8 screws and save for use on co-pilot side.
- Stretch headliner fabric back over fabric hooks on spar. Puncture fabric at same location of three holes used to attach visor bracket to channel clamp.

- Using three #8-32 Hex Flat Head screws, attach visor marked "pilot side" through headliner material to channel clamp.

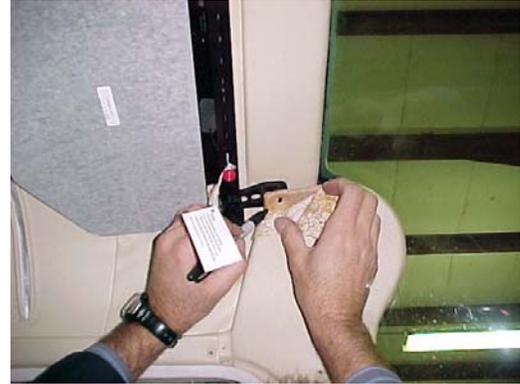
- Fit vertical trim piece back on post. Top left corner will slightly overlap visor bracket.
- Carefully mark location on trim piece that will be notched out to fit around bracket. (PLEASE NOTE: It is better to make *small* cuts and repeat procedure several times, as opposed to making a notch that is too big the first time!)
- Cut out notch and file cut edges of trim piece smooth.

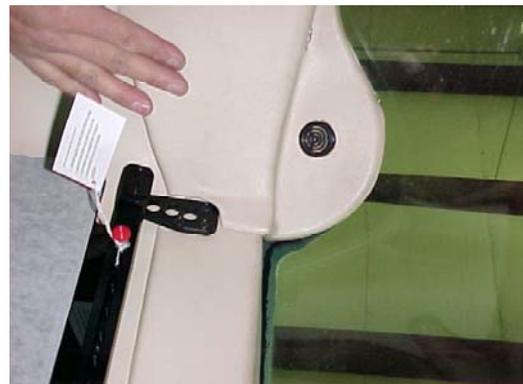
- Install warning horn in trim piece and re-attach trim piece to post.
- Repeat procedure for co-pilot side.

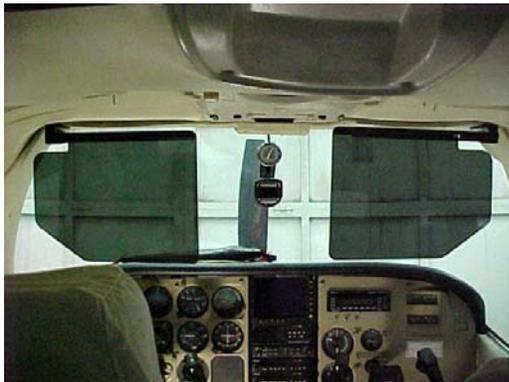
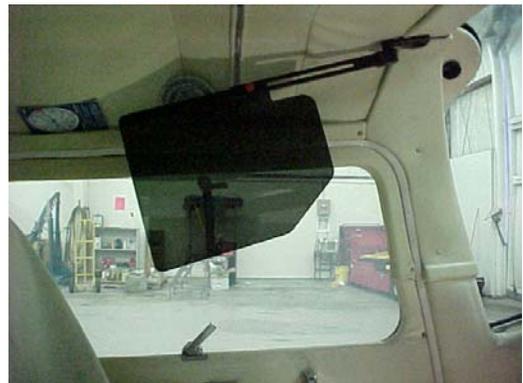
- Properly installed visor systems should hang level across windshield and swing unobstructed to side window. (See figures below)
